**DELAWARE RIVER BASIN
LOWER BIRCHWOOD LAKE DAM**

NDI NO. PA-00403
DER NO. 52-145

**PHASE I INSPECTION REPORT
NATIONAL DAM INSPECTION PROGRAM**

BY
Berger Associates, Inc.
Harrisburg, Pennsylvania
JUNE 1980

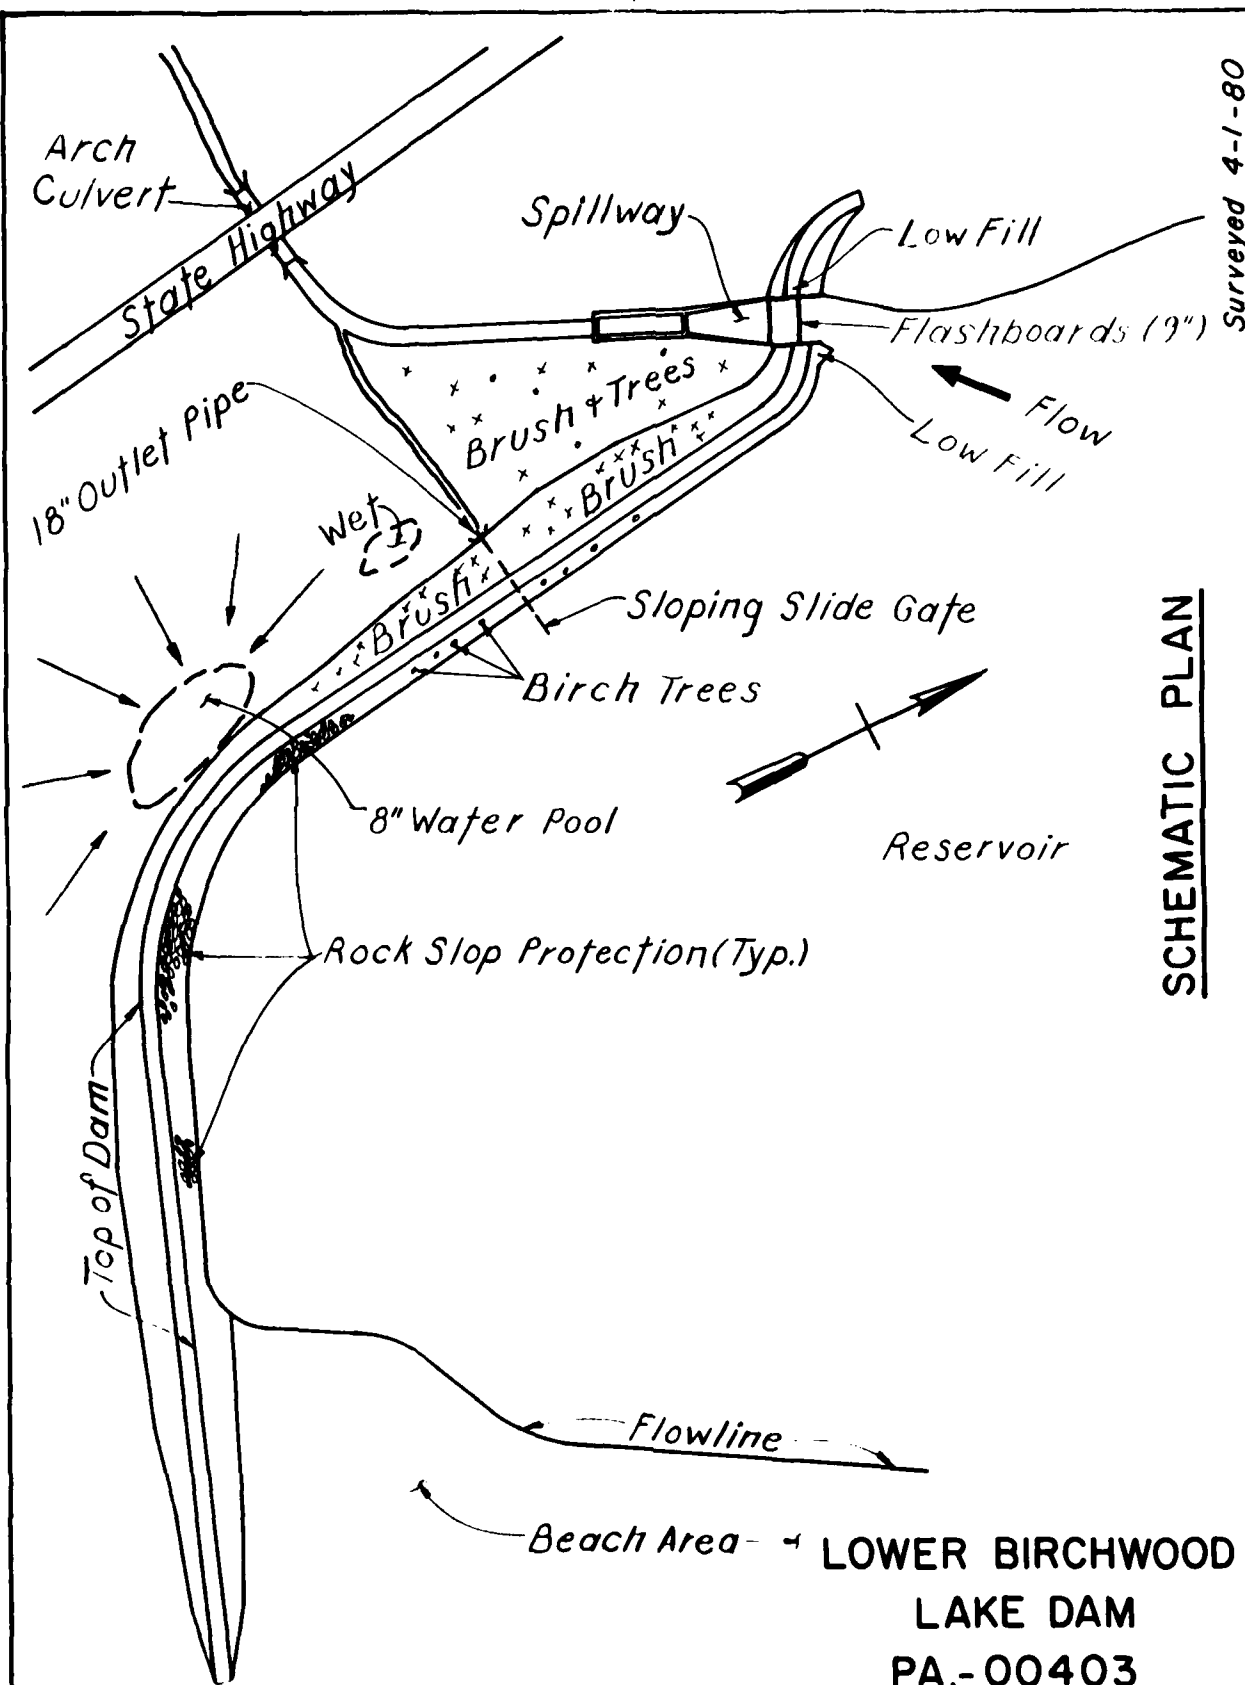
**LOWER BIRCHWOOD
LAKE DAM
PA.-00403
INSPECTION SURVEY
PLATE A-I**

this area (Photograph No. 6). It is recommended that this surface water be drained away from the toe of the dam. The horizontal alignment of the dam is curved (see Plate A-I). The vertical profile of the crest of the dam, as surveyed during this inspection, (Plate A-II) indicates that the top of the dam, with the exception of one area adjacent to the right spillway wall, is at least 0.3 feet higher than the design crest elevation.

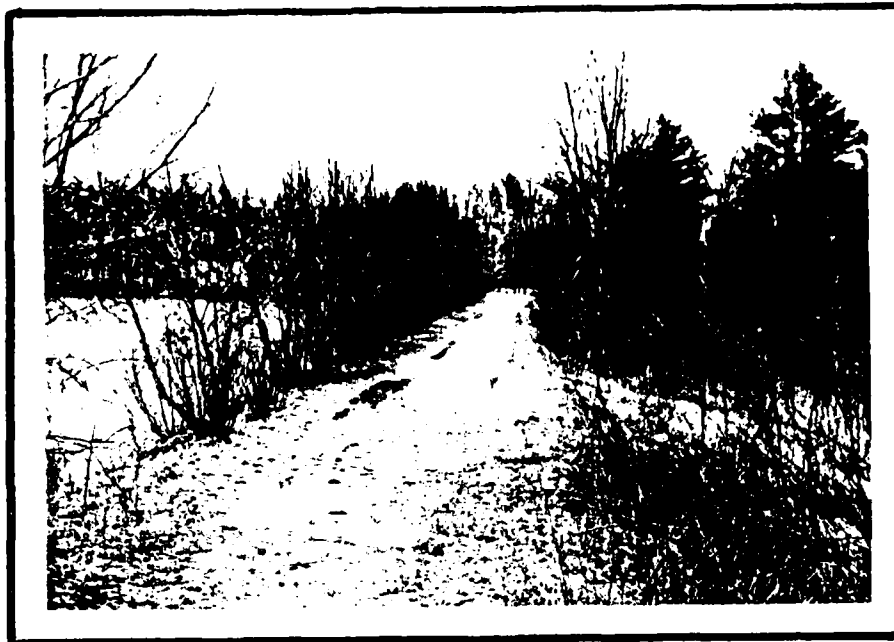
The upstream slope is protected by dumped riprap to the crest elevation of the dam. The upstream slope has a heavy growth of Birch trees over the full length of the dam (see Photographs No. 2, 3 & 4, Appendix C). This growth is considered undesirable for an earthfill dam. Some erosion of the upstream slope has occurred immediately adjacent to both sides of the spillway (Photograph No. 7). Although cutoff walls are preventing further erosion, it is recommended to place fill in these areas.

CREST OF DAM - NO. 2
NOTE: TREES AND BRUSH

1. That all brush and trees be removed from the embankment slopes and that a professional engineer, experienced in the design and construction of dams, be consulted for the removal of tree stumps and roots.
2. That the drawdown facilities be operated and maintained at least once each year.
3. That surface water be drained away from the toe of the dam.
4. That fill be placed to design crest elevation on both sides of the spillway at the upstream side.

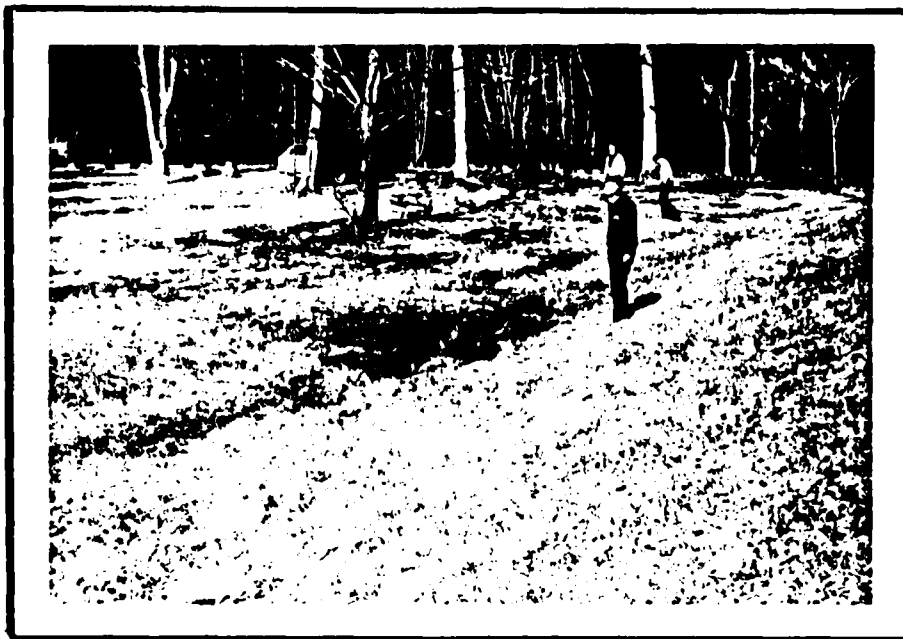
The immediate downstream area of the dam is flat and appears to drain toward the toe of the dam about halfway between the two abutments. On the day of inspection, an eight-inch deep pool of water was noted in

G. SEEPAGE	Free water was observed beyond the toe of the downstream slope (8" deep) near the center of the dam. Surrounding topo drains directly to this area.

POOL AT DOWNSTREAM TOE - NO. 6

3. That surface water be drained away from the toe of the dam.
4. That fill be placed to design crest elevation at both sides of the spillway at the upstream side.
5. That a formal surveillance and downstream warning system be developed for use during periods of high or prolonged precipitation.
6. That an operation and maintenance manual be prepared for guidance in the operation of the dam during normal and emergency conditions, and that a schedule be developed for the annual inspection of the dam and its appurtenant structures.
